# **FLOOD CONTROL AND WATER CONSERVATION DISTRICT**

## **Prepared for Winter Storms?**

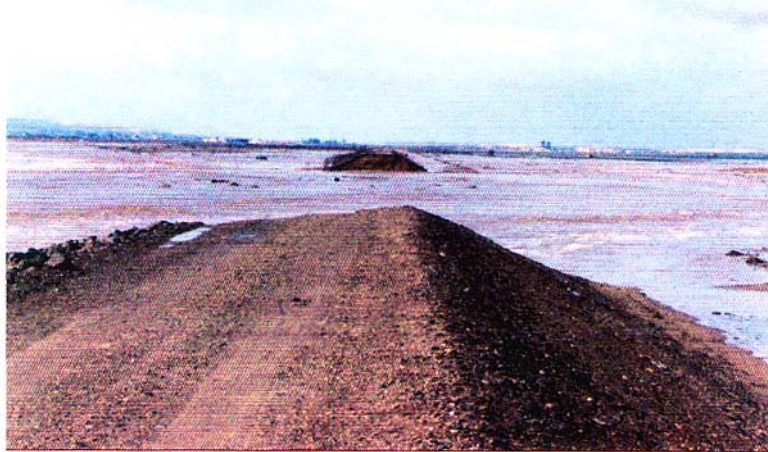
February 1980, and February 1998. In each of the first three damage events, the District was able to prevent a complete breach of the levee. In 1998, however, the Santa Maria River shifted course and struck directly against the north levee, causing a 1,000-foot breach near Bonita School Road and flooding of adjacent farmland (see Exhibit 4). The breach cost over \$1 million to repair.

Exhibit 4. Photograph of the 1,000-foot breach in 1998 that flooded adjacent farmland.

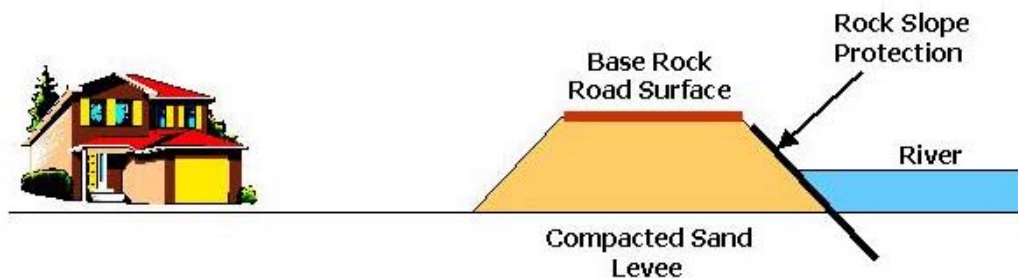
The Santa Maria levee is a berm constructed of sand and gravel taken from the river channel and faced with rock on the slope facing the riverbed. Its height varies from 16 to 22 feet. See Exhibit 5.

Exhibit 5. The levee is a berm constructed of sand and gravel and faced with rock.

The Santa Maria levee is at risk primarily because the rock used on its face is deteriorating. Because the core of the levee is primarily sand, the rock face is the

The original rock facing has not been replaced or augmented along most of the levee, except near the Suey Bridge. Just west of the bridge large limestone rocks from near Lake Cachuma have been set on the levee face – dense, hard rocks, ideally suited to the purpose. In contrast, the rock that was originally used on the levee is basalt with quartz veins running through it. This rock spontaneously decomposes into smaller fragments by fracturing along fault lines, presumably due to the action of moisture and thermal stress. The smaller the pieces of rock, the less protection the rock provides to the face of the levee.

When the Grand Jury visited the levee, the deterioration of the rock facing was clearly visible. The contrast between the original rock and the reinforced area near the Suey Bridge was striking. The levee has failed before, the rock facing continues to deteriorate, and the City of Santa Maria is at risk.

The District is aggressively pursuing protective measures to increase the reliability of the levee. The study report identifies measures appropriate to each segment of the levee, resulting in a total cost estimate of \$38.25 million. Of this amount \$34.34 million is required for just two segments, between Bradley Canyon and Suey Road and between Suey Road and Blosser Road. These segments protect the City of Santa Maria from inundation.

Now that a comprehensive engineering study of the Santa Maria levee is available, the funding to reinforce the levee should be secured and applied to the solutions recommended in the study report.

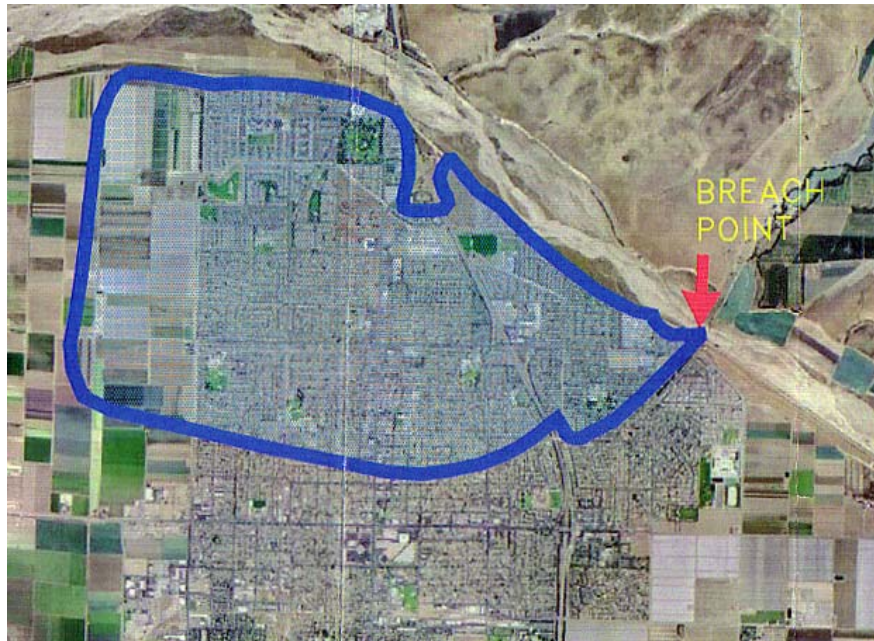
Unlike the impact of Hurricane Katrina on the New Orleans levees in 2005, there is virtually no danger of the Santa Maria River overtopping the Santa Maria levee. Instead, failure has occurred, and is likely to occur in the future, when the meandering flow of the river strikes directly against the levee. When this happens, a local scour action undermines the protective rock at the toe of the levee. Once this protective layer slumps and fails, there is only compacted earth to resist the water. If the flow continues, it quickly scours and erodes the exposed material to create a localized breach. Unless the breach is identified and filled immediately, it rapidly grows both up- and downstream, allowing the river to inundate the area behind the levee as happened in 1998. Exhibit 6 shows the estimated inundation area in the event of a breach near the Suey Bridge superimposed on an aerial photo of Santa Maria. A large area of the city would endure flooding should such a breach occur.

Exhibit 6. A levee breach near the Suey Bridge would flood a large portion of the City of Santa Maria.
